# **Injected Mineral Fibre Full Fill Cavity Wall Insulation, Workmanship, Voids and Heat Loss**

*A White Paper*

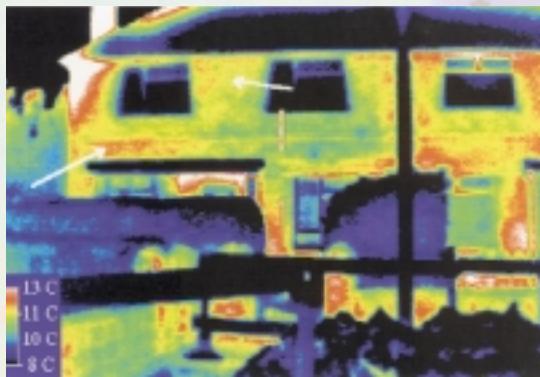
This image shows the front elevation of a notionally insulated property to the left. The adjoining unit to the right is uninsulated.

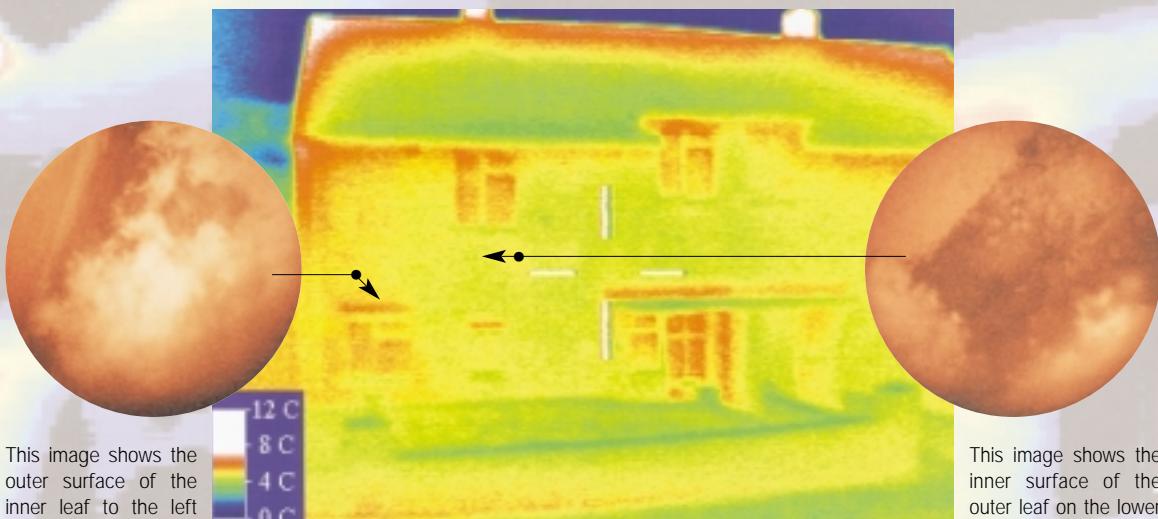
Image 1

This image shows the outer surface of the inner leaf to the left hand side of the image. The mineral fibre is seen both in the centre and to the right of the image. This is approximately 300mm away from the viewing position and thus indicates a void. The darker area to the top of the image indicates that the mineral fibre is of low density at that location and it can be seen that the mineral fibre does not fully fill the cavity at this position.

This image shows the front elevation of property #4 and indicates some irregular heat loss patterns below the upper left hand window and between the lower left hand window and the eaves line. Thermal bridging at the lower window units appears as red rectangular patterns.

This image shows the inner surface of the outer leaf on the lower right hand side. The mineral fibre is seen to the lower left and to the upper right. A distinct void in the mineral fibre is noticed in the centre of the image as the darker area. This void extends approximately 0.5m to the left and right of the bore hole location.

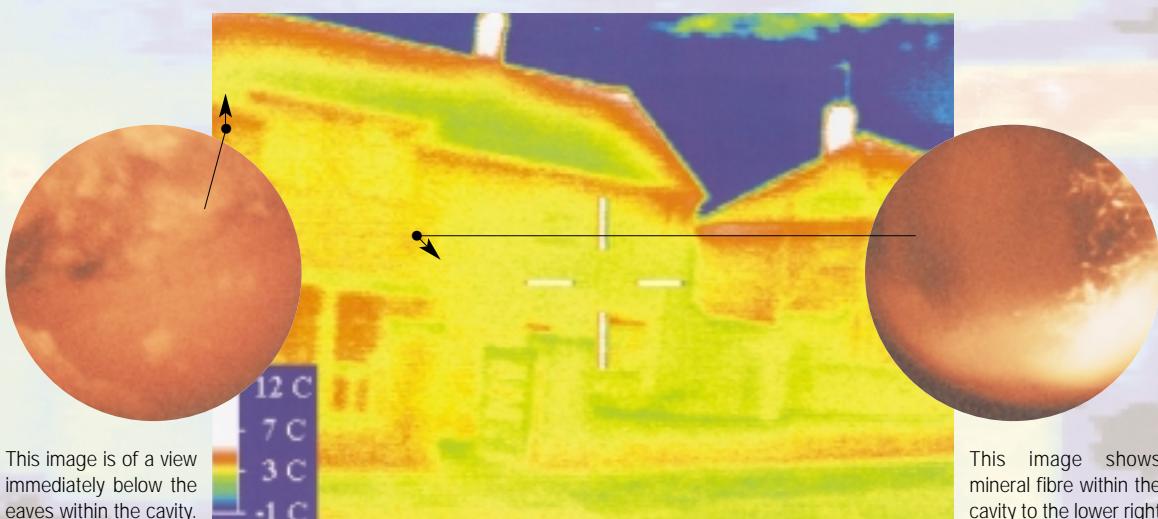
Image 2

This image is of a view immediately below the eaves within the cavity. The inner surface of the outer leaf is to the bottom of the image and the mineral fibre to the top. It is obvious that a clear void exists across the cavity at this location.

This image shows the front elevation of properties #62 and #64 which comprise the left hand of the two semi detached blocks in the image. Properties #62 and #64 indicate areas of increased heat loss.

This image shows mineral fibre within the cavity to the lower right illuminated by the light source and a darker area to the upper left which indicates a void behind the mineral fibre immediately in front of the endoscope. This void is approximately 500mm in diameter.

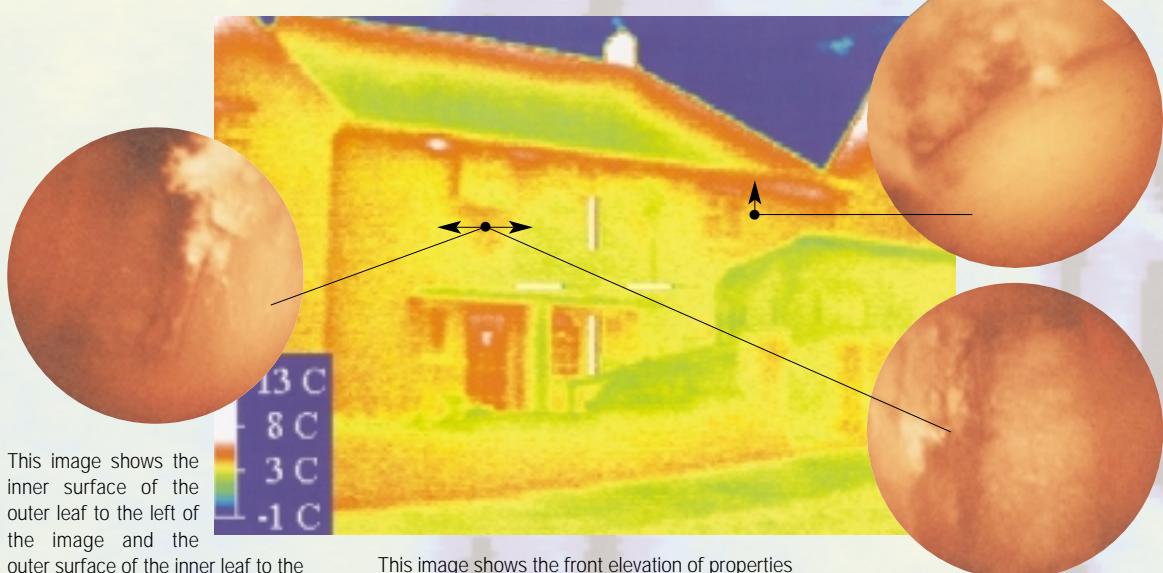
Image 3

This image shows the inner surface of the outer leaf to the left of the image and the outer surface of the inner leaf to the right. A large void exists in the mineral fibre. The darker band running vertically in the centre is mineral fibre approximately 1 metre away.

This image shows the inner surface of the outer leaf to the lower right and the mineral fibre to the upper left. A void exists and small gaps are present between the insulant and the outer leaf.

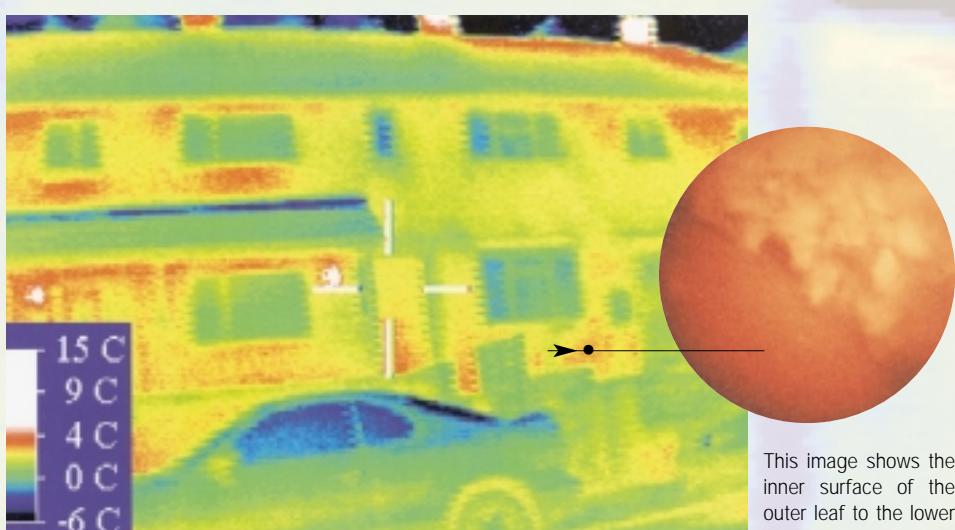
Image 4

This image shows the inner surface of the outer leaf to the lower left and the mineral fibre to the upper right. A void exists at this location and gaps exist between the mineral fibre and the outer leaf.

This image shows the inner surface of the outer leaf to the right of the image. The mineral fibre is a band running vertically in the centre of the image. This mineral fibre is 500mm away. This is a large void.

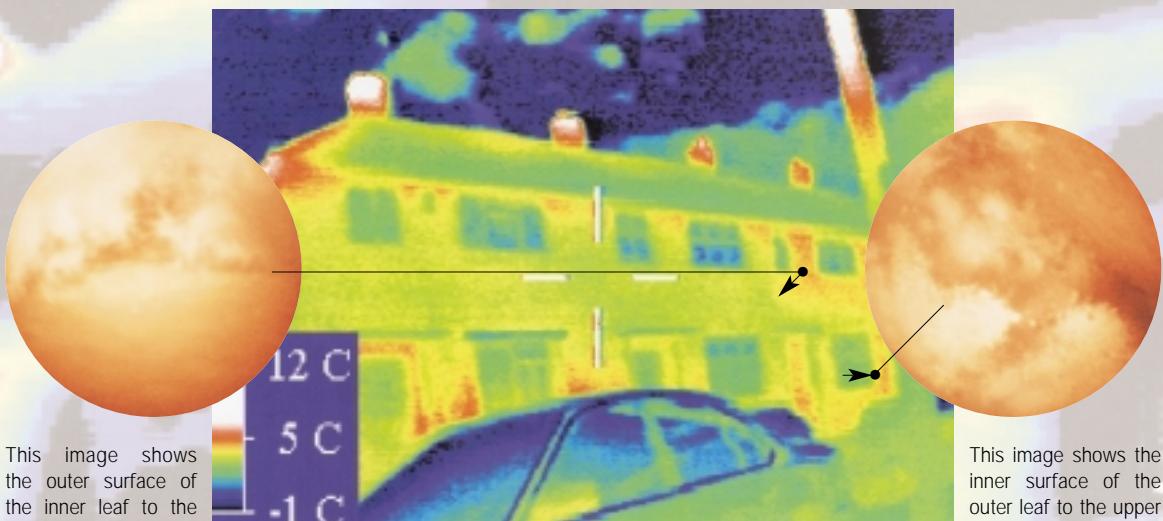
Image 5

This image shows the outer surface of the inner leaf to the bottom and the mineral fibre to the top. The mineral fibre is 300-500mm away from the viewing position proving the existence of a void at this location. The darker area in the centre also indicates that the insulation is of low density beyond this position.

This image shows the front elevation of properties #21, #23, #25 and #27. The property endoscoped is the only property owned by local authority A and the only property insulated with injected mineral fibre full fill cavity wall insulation under the same contract as the others surveyed. The red patterns indicate higher levels of heat loss around windows.

This image shows the inner surface of the outer leaf to the upper right and the mineral fibre to the lower left. It is clear that small gaps exist within the mineral fibre and that a gap exists between the mineral fibre and the inner surface of the outer leaf. This gap varied from 10mm at the lower right to 40mm at the upper left of the image.

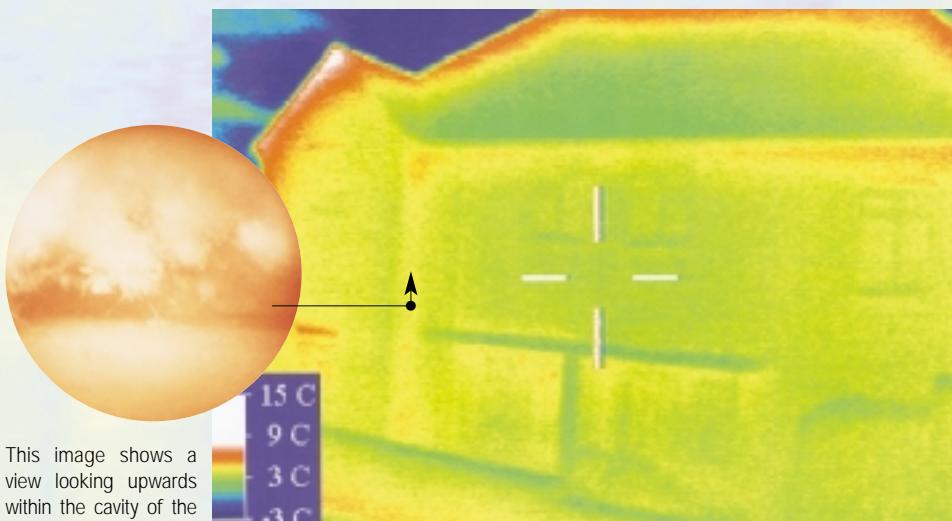
Image 6

This image shows a view looking upwards within the cavity of the short return wall. The inner surface of the outer leaf is seen to the bottom and the mineral fibre to the top. Across the centre the dark band is the underside of the first floor window cill. A distinct void exists at this location and the mineral fibre clearly varies in density.

This image shows the front elevation of properties #18 and #20 and shows some localised heat loss at the short return wall to the left. The vertical red band at ground floor level indicates possible missing insulation.

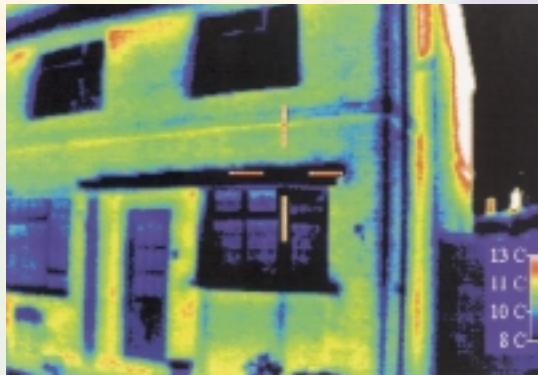
Image 7

This image shows the front elevation of property #4 and indicates some increased heat loss close to ground level at the bay window. This is likely to be due to missing or low density insulation. Thermal bridging is noticed around the door porch junctions with the wall.

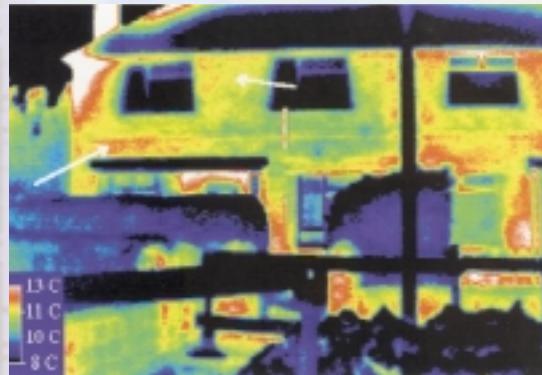
Image 10

This image shows the front elevation of property #35 to the left. The adjoining unit to the right is uninsulated. The large red patterns above the entrance doorway to property #35 and between its upper windows indicate likely missing or low density insulation.

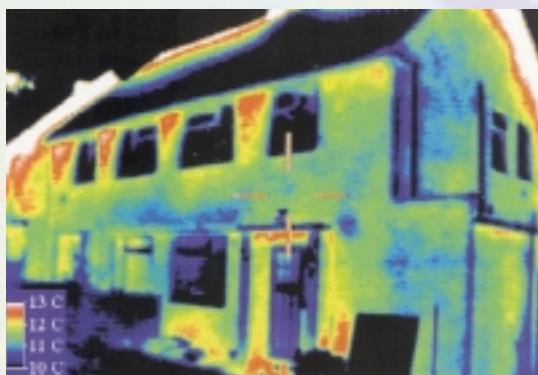
Image 8

This image shows the front and gable elevation of property #24. The irregular patterns across the entire wall indicate significant missing or low density insulation, particularly immediately below and adjacent to windows.

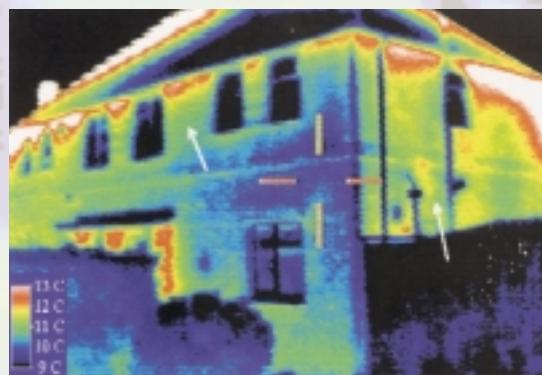
Image 11

This image shows the front and gable elevations of property #40 to the right. The light green areas on the front elevation indicate likely low density insulation. The gable elevation shows increased heat loss around pipe penetrations and below the upper window. This is likely due to missing insulation.

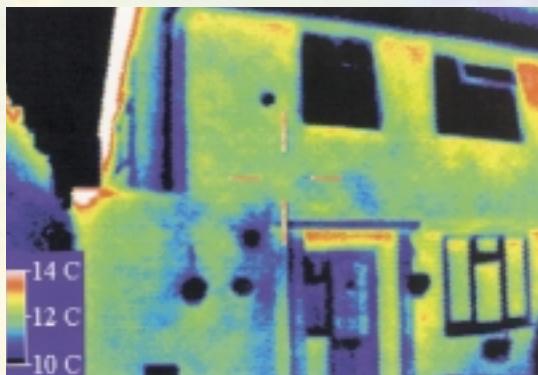
Image 9

This image shows the front elevation of property #30. The red and yellow patterns below the upper windows, at the party wall location, and between the entrance porch and living room window, indicate likely missing or low density insulation.

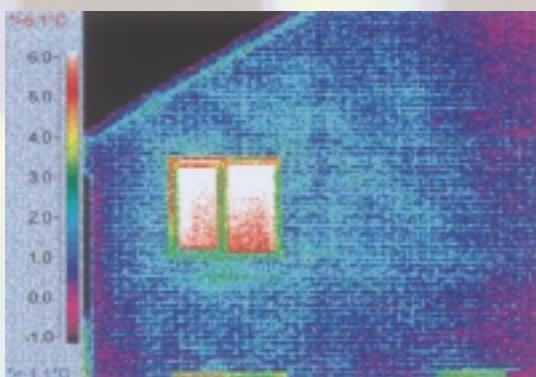
Image 12

The image shows a gable wall with a relatively even surface temperature. It is insulated with Kingspan partial fill insulation. There are well insulated lintels with no debris. Very little thermal bridging at this position can be identified. There is also very little air leakage at the verge. It should be noted that the rooms behind are well heated which further displays the well insulated nature of the construction.

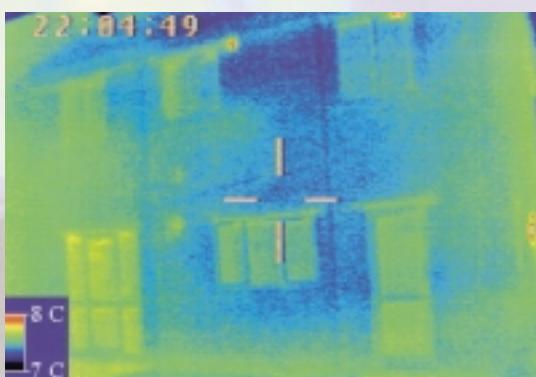
Image 13

This image displays the uniform thermal patterns which are associated with a well performing wall insulation system. It is insulated with Kingspan partial fill insulation. Some localised surface cooling is noticed due to wind effects.

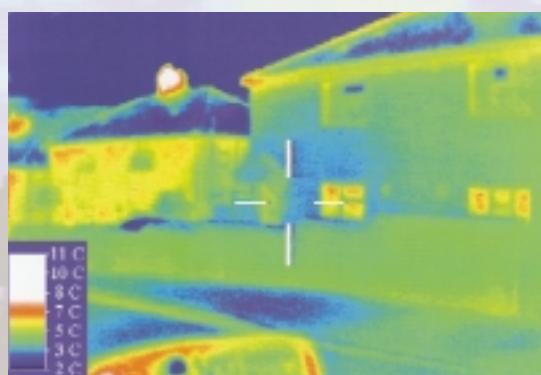
Image 14

The externally insulated semi detached block to the right shows an even temperature distribution across the wall surface. This is in contrast to the semi detached block to the left, insulated with injected mineral fibre full fill cavity wall insulation which displays a distinctly higher surface temperature and irregular thermal patterns which are likely to be related to insulation defects.

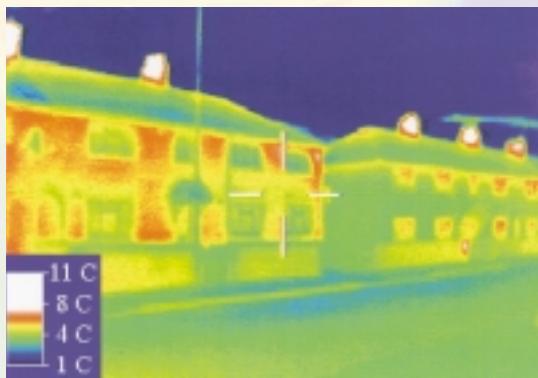
Image 15

This image contrasts the terrace insulated with injected mineral fibre full fill cavity wall insulation on the left with the externally insulated terrace on the right. The latter shows a uniform level of thermal performance while the former displays higher surface temperatures and irregular thermal patterns associated with possible insulation defects.
