## Cavity Wall Insulation injection hole drilling pattern – Gable Elevation - As Fixed

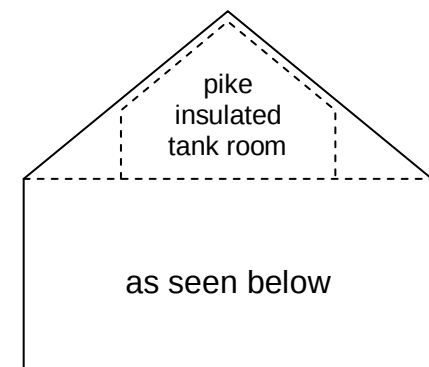
Note 1: This is a gable wall with a pike (triangle) above eaves level. I am not concerned with itemising the pike feature. It was drilled and insulated as I saw it being done. I have not and will not be checking the drilling pattern. I would like to know why pikes are included in insulation work. I can only surmise it is in connection with inhibiting cavity condensation which might affect lower insulation. If there is any deficiency (I have no reason to believe there is), it cannot affect the heat loss of my home given the roof space is insulated to Scandinavian standards and a substantial portion of the pike brickwork is insulated internally where it forms part of a tank room for cold water (potable) storage. The boiler is a system boiler at ground floor level serving a super-duty hot water cylinder in the tank room.

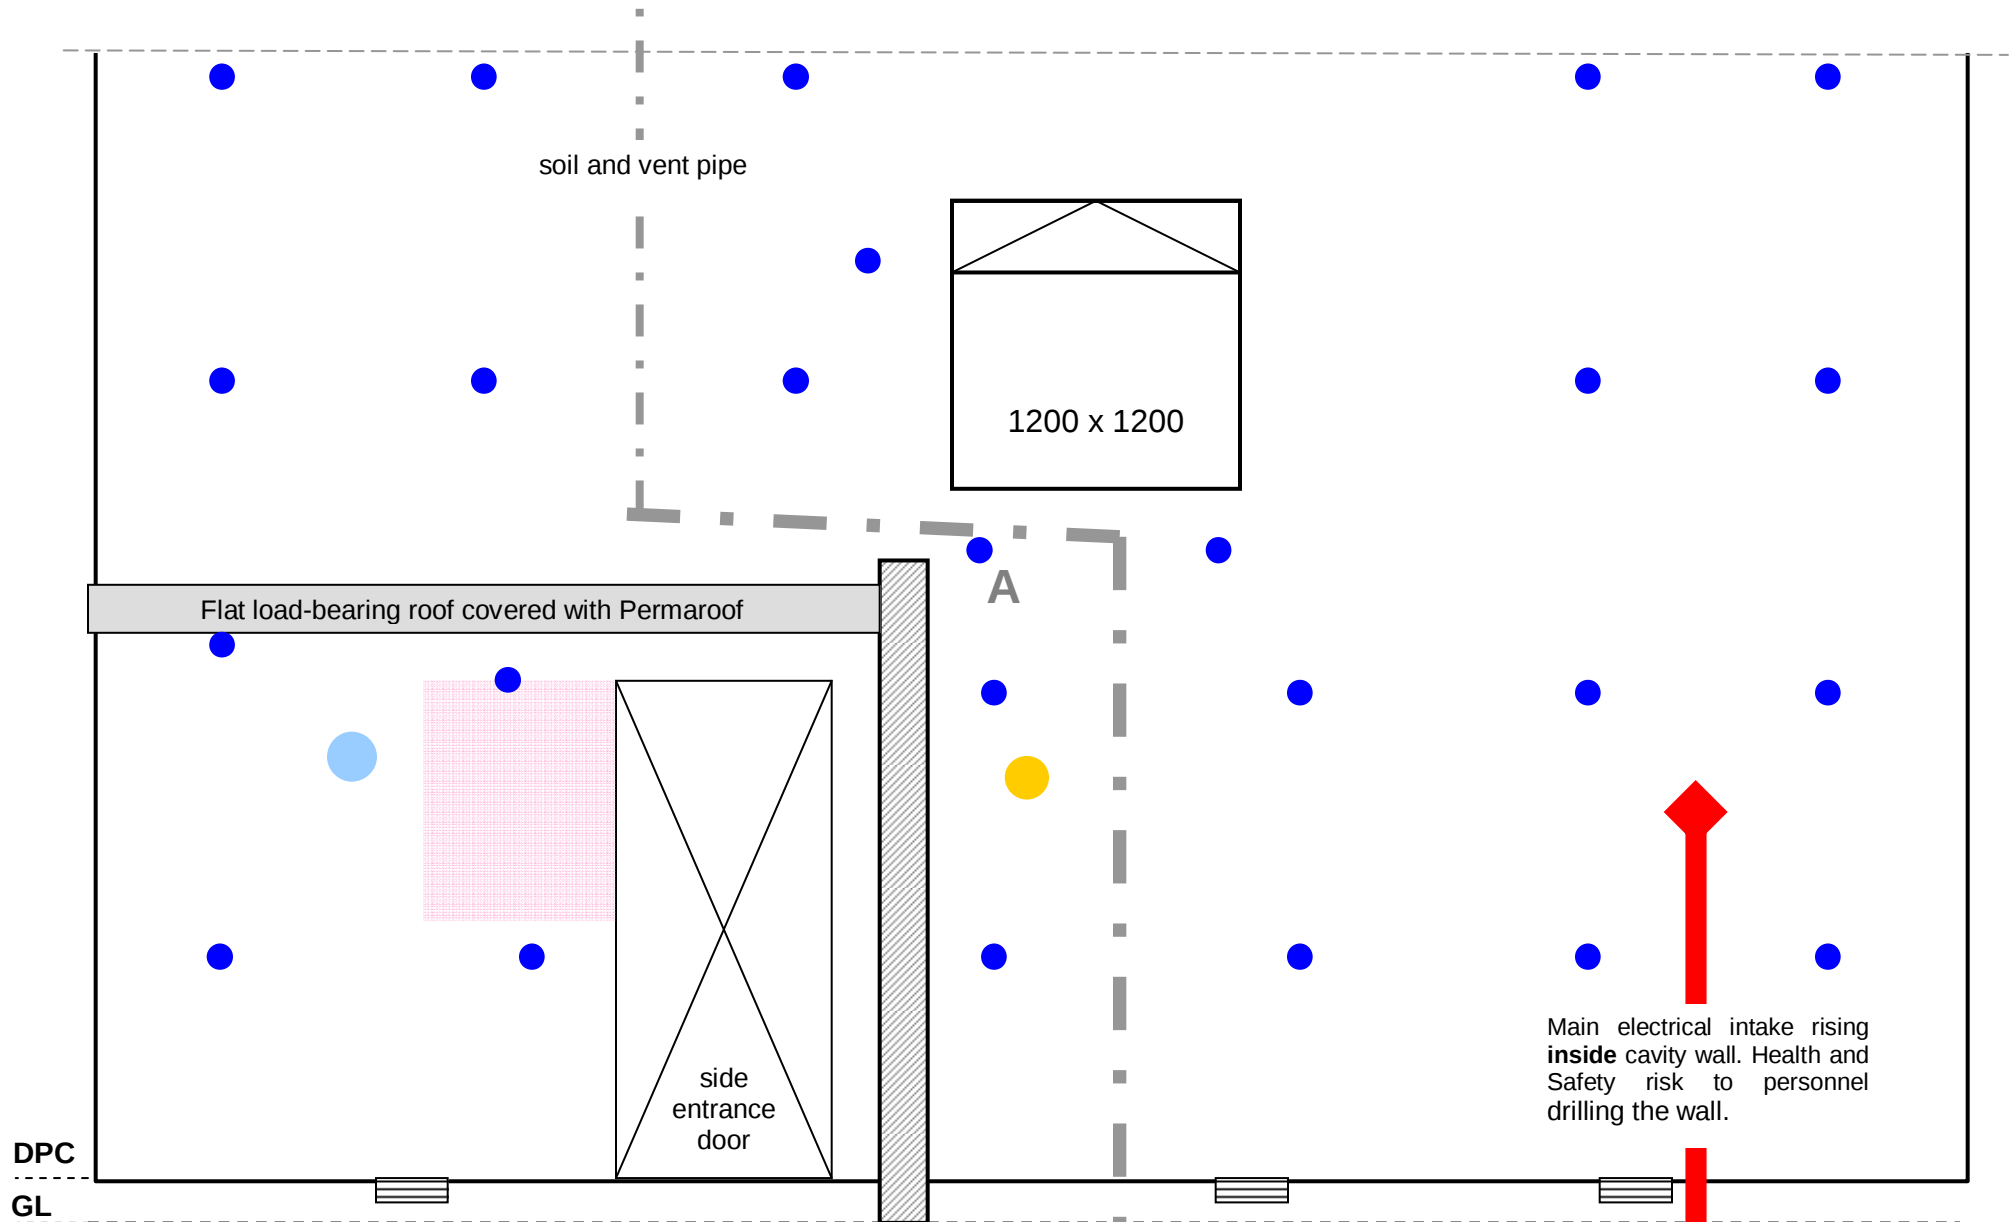
# Cavity Wall Insulation injection hole drilling pattern – Gable Elevation - As Fixed

Note 2: The 1200 x 1200 window on this elevation is the area where a substantial void is known to exist. The left hand injection hole marked A is just under the horizontal section of the soil pipe. Careful examination shows that the injection hole must have been drilled at a slight angle upwards to avoid the 25mm drill bit damaging the plastic soil pipe. It is of course possible that the hole was started, abandoned and the hole filled like the others without injection being carried out. I have no evidence to suggest that is the case but even if the hole was abandoned, the other injection points should easily have coped.
